Investigation of Welded Studs on Overhead Sign Structures

February – June 2006

**ABSTRACT:**

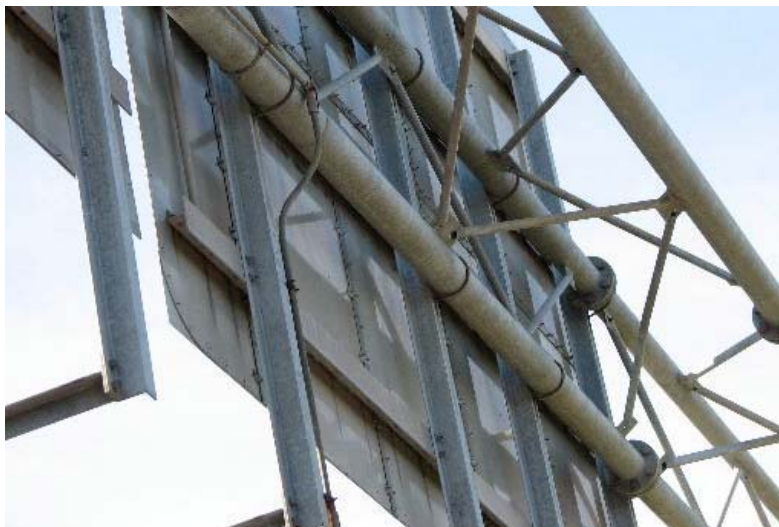
**Figure 1 - T-clip Attachment Method**

The second problem for stud inspection was the T-clip design (See Figure 1). Although this design was replaced over 20 years ago, nine T-clip signs on five structures fell into our survey. The T-clip design uses a T-shape section on the back of the sign. Although a count of the studs can be obtained from the bolts that go through the web of the T-shape, it is impossible to determine if the studs are intact from the ground.

If a routine inspection cannot be implemented, we recommend that the T-clip design be replaced. This connection has not been utilized for new signs in over 20 years. The Asheville sign that fell utilized this connection design. The connection tends to use less studs per bar, and the welds are older. Many of the signs have been overlayed, increasing the weight and sometimes the wind area of the signs. We estimate that 50 to 100 structures may still utilize the T-clip design. The signage on an overhead structure is estimated to cost around \$6000 per structure, with \$1200 for the disposal of the old sign and the erection of the new one. The total cost could approach \$1,000,000 depending on the final number of T-clip signs and whether the traffic control expenses can be mitigated. The timeline for this expense should be extended, so that many of these signs would be replaced for other reasons.

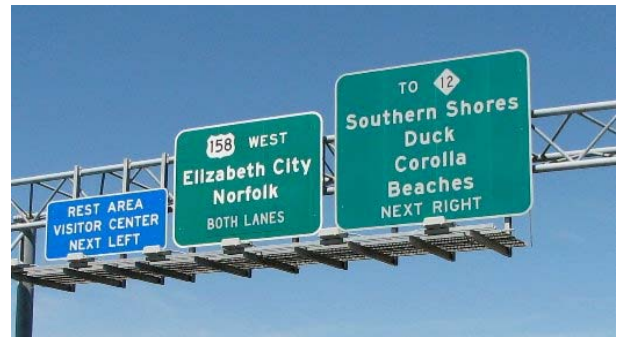
Figure 2 - Sign Structure 270057

County	Dare		
Division	1		
Route	US 158 WBL		
Structure Type	Span		
AADT	14,000		
# 2770057	Sign 1	Sign 2	Sign 3
Size	12'x5'	13'x10'	15'x12'
Z-bars	2	3	3
Total Studs	105	228	264
Missing Studs	88	73	1
% Missing	83.8	32.0	0.4
Thru-bolts	Yes	Yes	Yes
Fab/Erect Date	1999	1999	2003

Unquestionably, the worst structure visited was 270057 in Dare County (Figure 2). This full span had suffered heavy stud failures. Although the largest sign had only one stud missing, it had been replaced in 2003. The small “REST AREA” sign (Sign 1) had lost over 80% of its studs. Division forces thoroughly thru-bolted each panel of the sign. The middle sign (Sign 2) had 32% stud failure with only the standard thru-bolts and the ends of the Z-bar (Figures 4 - 6).

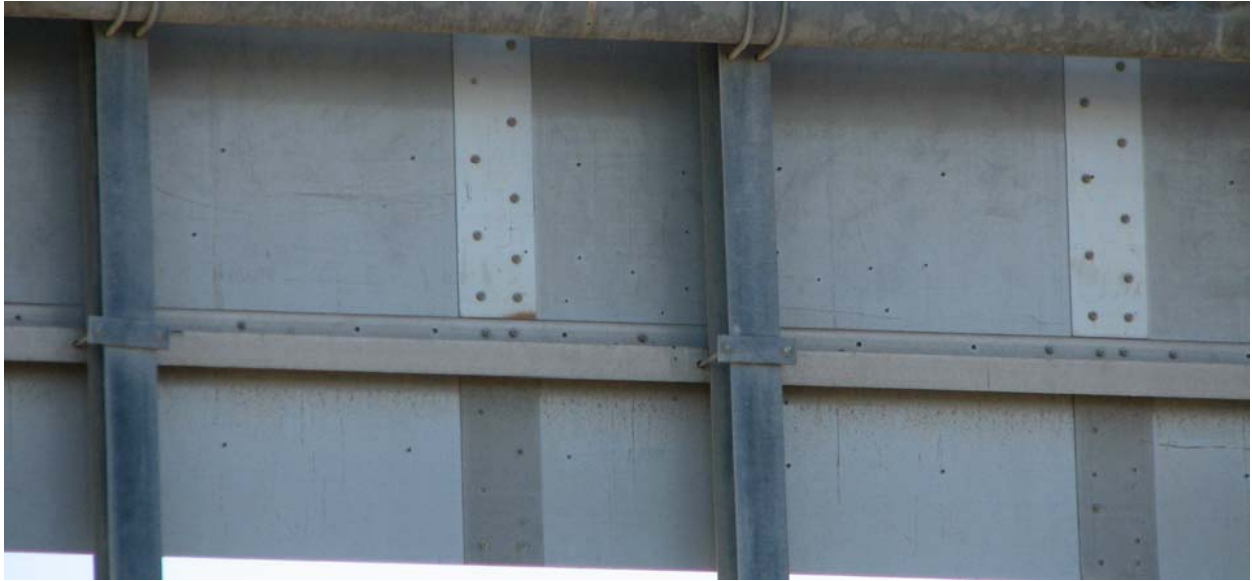
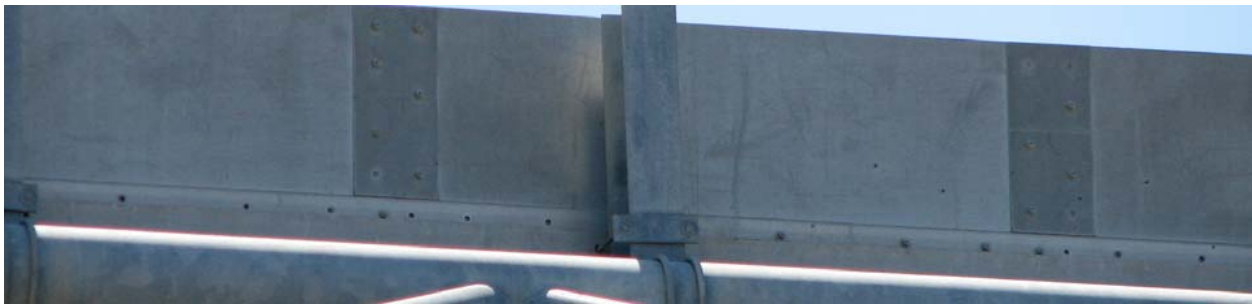
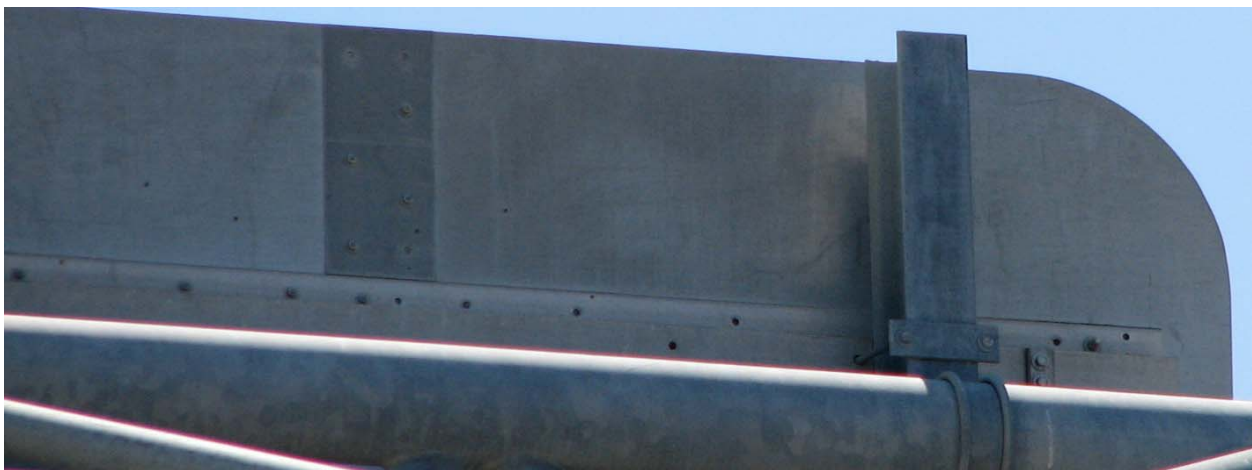
**Figure 4 - Sign 2 Bottom Z bar**

**Figure 5 - Sign 2 Top Z bar**

**Figure 6 - Sign 2 Top Z bar**

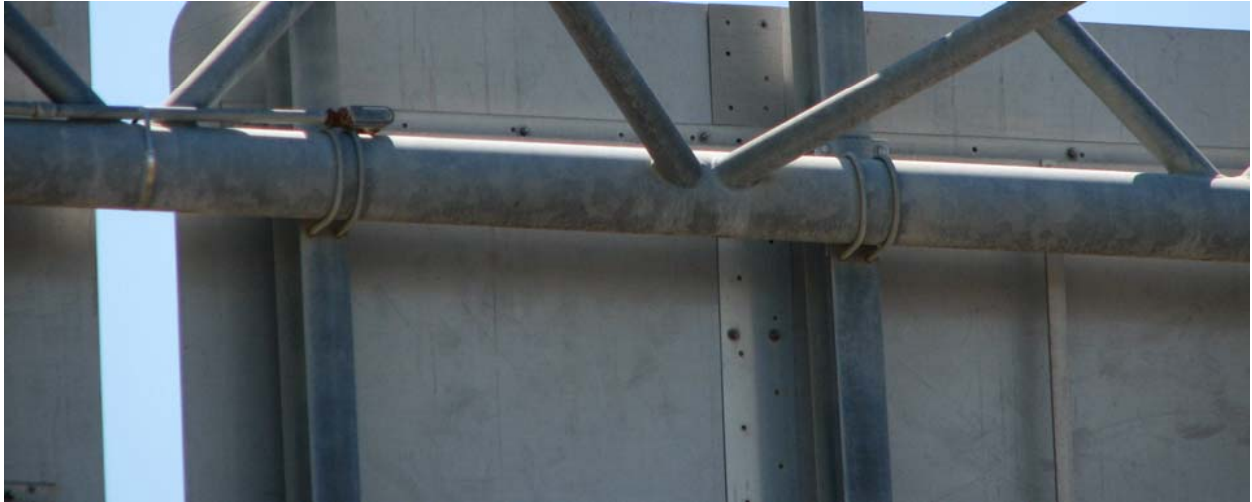
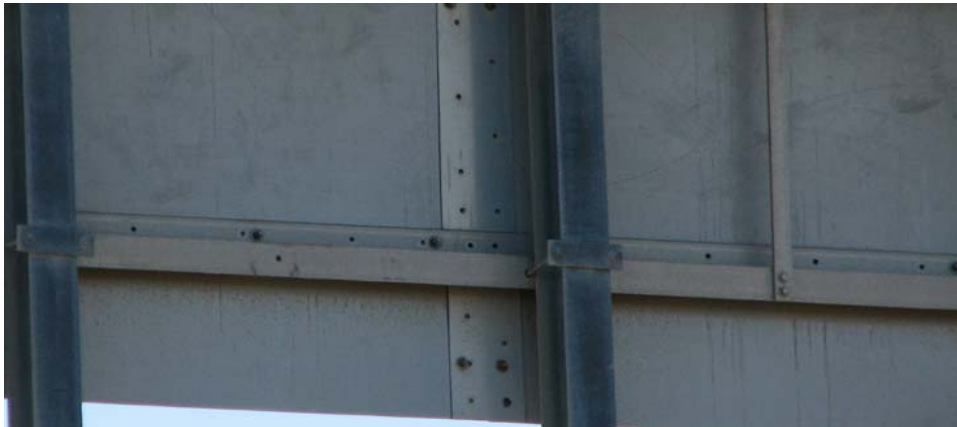
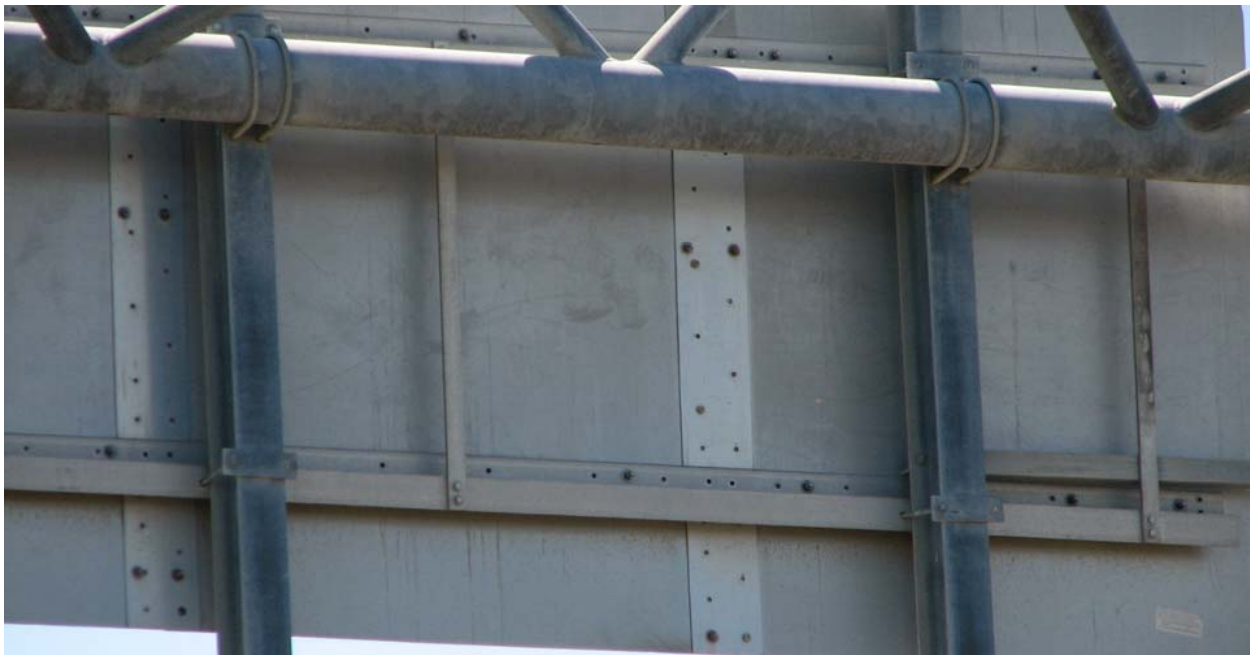
**Figure 7 - Sign 1 Top Z bar**

**Figure 8 - Sign 1 Bottom Z bar**

**Figure 9 - Sign 1 Bottom Z bar**

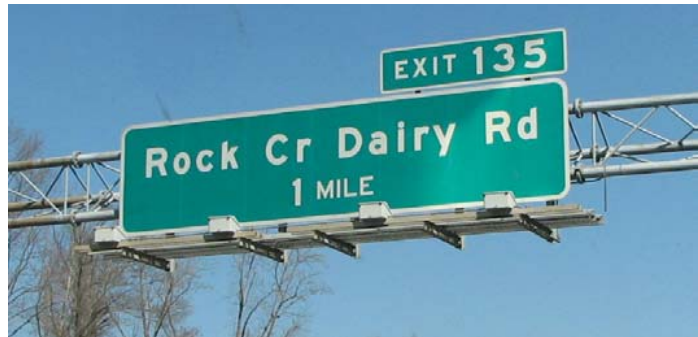
**Figure 10 - Sign Structure 400656**

County	Guilford
Division	7
Route	I-40 / I-85 EBL
Structure Type	Span
AADT	40,500
# <b>400656</b>	Sign 4
Size	26'x7'
Z-bars	3
Total Studs	288
Missing Studs	35
% Missing	12.2
Thru-bolts	Yes
Fab/Erect Date	1992

This single sign span in Guilford County (Figure 10) experienced the second highest stud failure rate at 12.2%. This exceeds the new sign specification of 10%. There were blocked visibility issues on the top Z-bar, and the failure rate may be slightly higher than 12%.

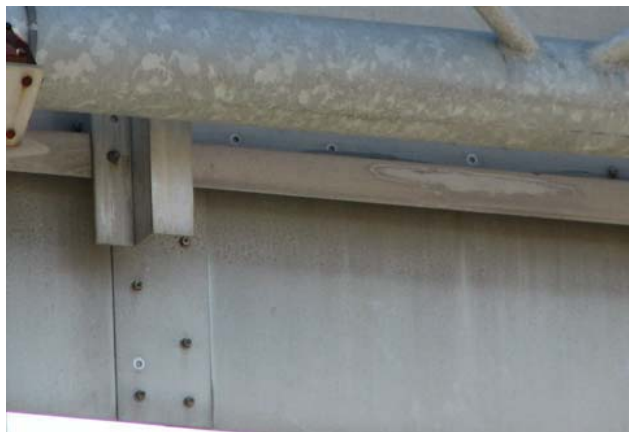
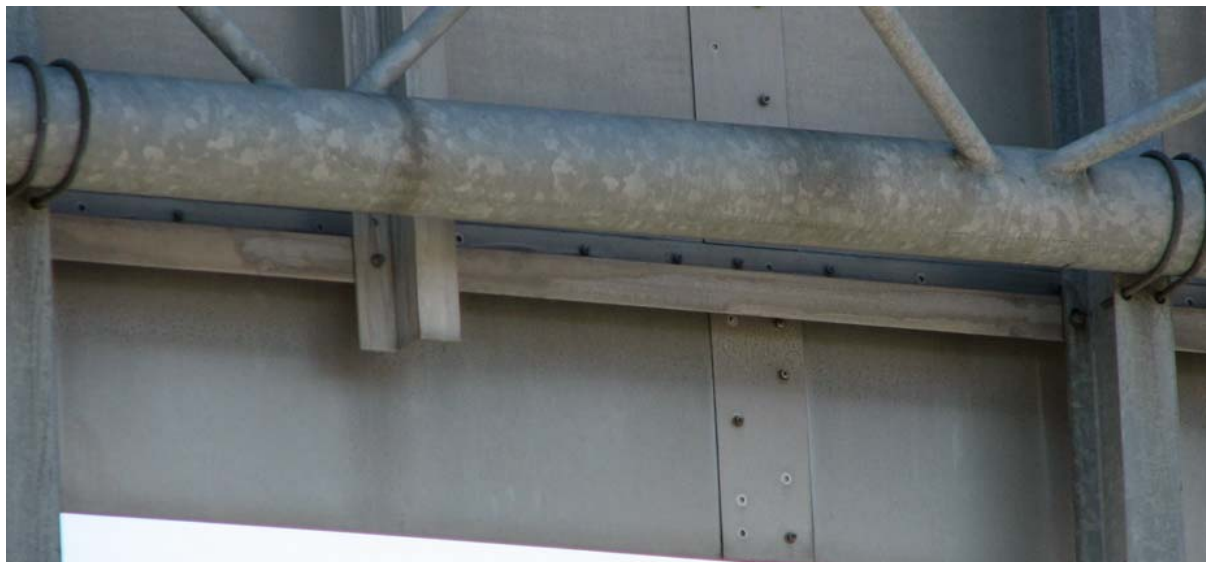
**Figure 11 - Sign 4 Bottom Z bar**

**Figure 12 - Sign 4 Bottom Z bar**

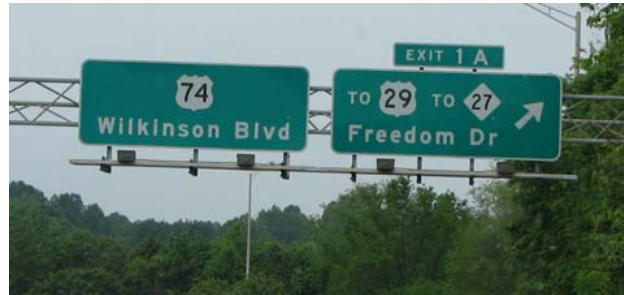
**Figure 13 - Sign Structure 590491**

County	Mecklenburg	
Division	10	
Route	US-74 WBL	
Structure Type	Span	
AADT	24,750	
# 590491	Sign 5	Sign 6
Size	18'x7'	18'x7'
Z-bars	2	2
Total Studs	226	226
Missing Studs	23	25
% Missing	10.2	11.1
Thru-bolts	No	No
Fab/Erect Date	None	None

This structure holds Sign 5 and 6 in Mecklenburg County (Figure 13). Both signs just exceed the 10% failure criteria at 10.2% and 11.0%. The absence of thru-bolts dates the signs to 1992 at the latest. The structure was recorded as erected in 1985. The signs may be that old as well. The failures on this sign are primarily in the top Z-bars, as pictured.

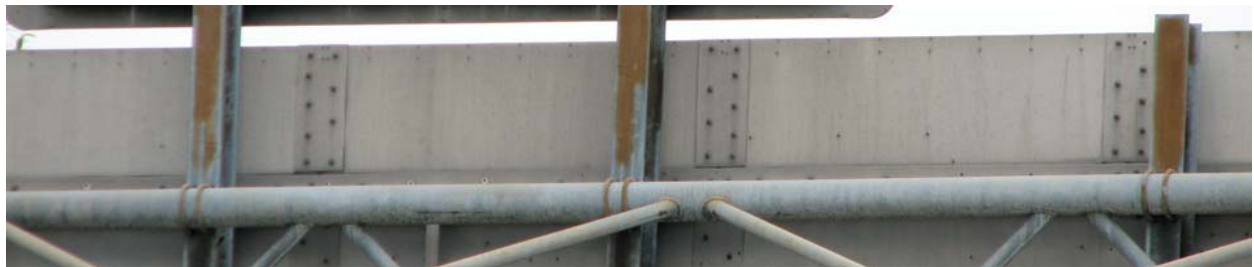
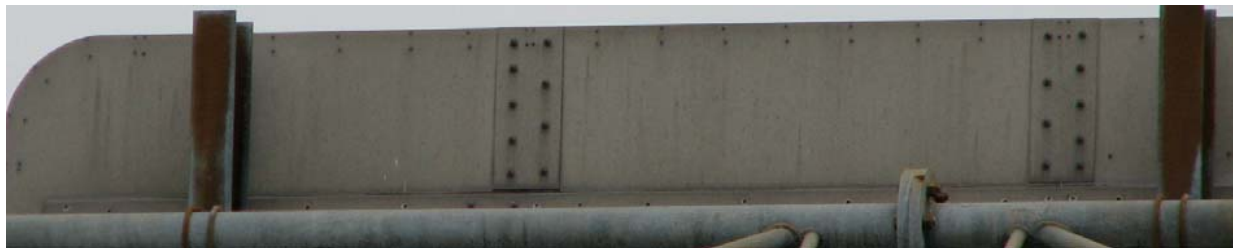
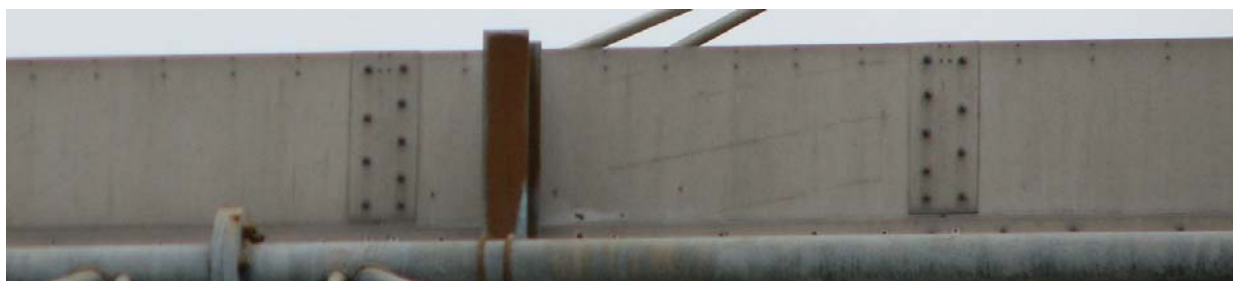
**Figure 14 - Sign 6 Top Z bar**

**Figure 15 - Sign 5 Top Z bar**

**Figure 16 - Sign 5 Top Z bar**

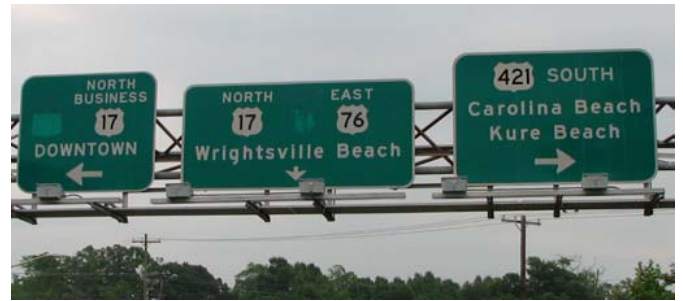
**Figure 17 - Sign Structure 640066**

County	New Hanover		
Division	3		
Route	US 421, 17, 74, 76		
Structure Type	Span		
AADT	23,000		
# 640066	Sign 7	Sign 8	Sign 9
Size	10'x10'	15'x8'	12.5'x11'
Z-bars	3	2	3
Total Studs	136	153	207
Missing Studs	11	13	18
% Missing	8.1	8.5	8.7
Thru-bolts	No	No	No
Fab/Erect Date	1988	1988	1988

None of the signs on the structure (Figure 17) could be confirmed to exceed 10% from the ground. All three signs exceeded 8% failure and had bottom Z-bars that could not be inspected. Sign 8 had both of its Z-bars completely obscured, eliminating 40% of the studs from the inspection. Although no Z-bar failures were recorded and it is possible that none of the obscured areas were missing any studs and, it is more likely that at least 1 of the signs exceed the 10% failure rate. Only three additional missing studs on any of the signs result in exceeding the failure rate.

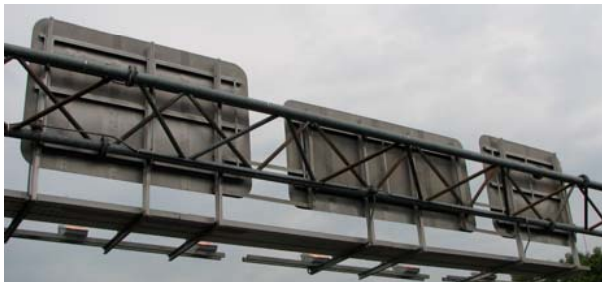
**Figure 18 – Obscured Z bars**

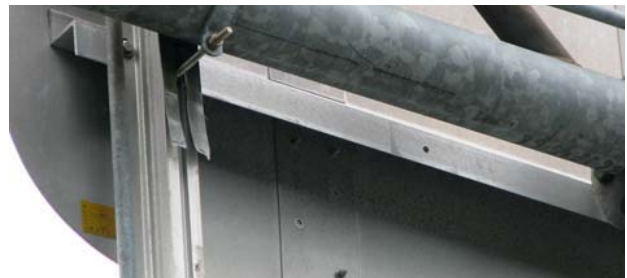
**Figure 19 - Sign 7 Obscured Z bar**

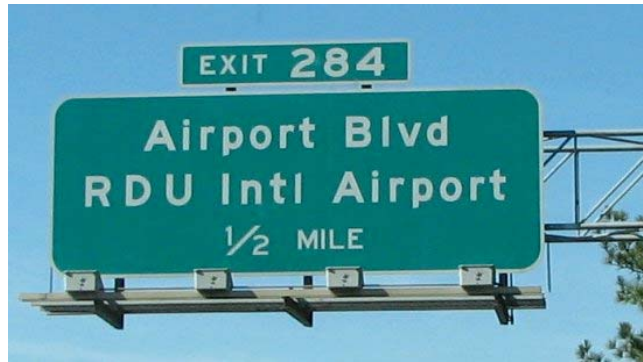
**Figure 21 - Sign Structure 910896**

County	Wake
Division	5
Route	I-40 WBL
Structure Type	Cantilever
AADT	61500
# 910896	Sign 10
Size	21'x9'
Z-bars	3
Total Studs	310
Missing Studs	25
% Missing	8.1
Thru-bolts	No
Fab/Erect Date	1989

This sign does not have thru-bolts and was erected in 1989 (Figure 21). The majority of the failures occurred in the middle and bottom Z-bar, creating a potential peeling problem. The sign is approaching the 10% failure rate, and if peeling is causing the localized stud failure, heavy wind loads could increase the sign failures.

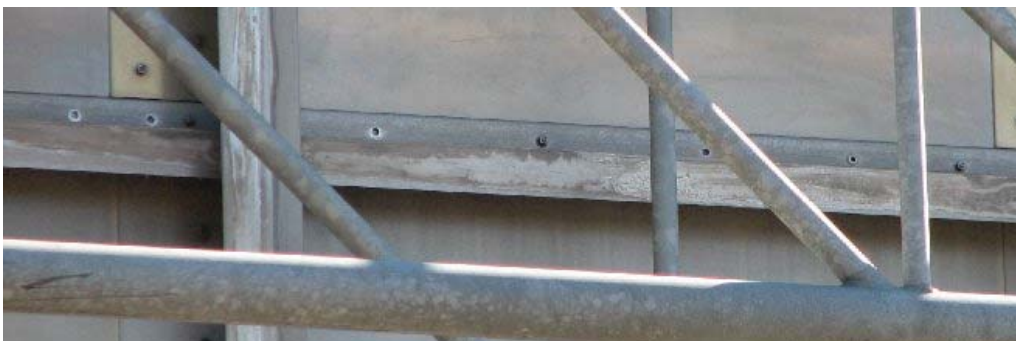
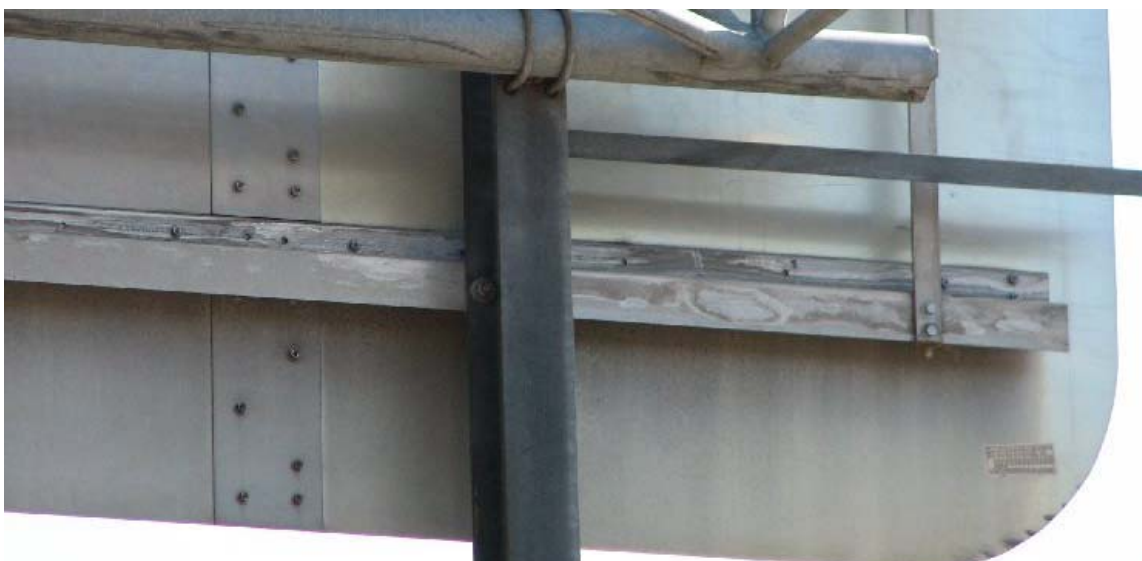
**Figure 22 – Sign 10 Middle Z bar**

**Figure 23 – Sign 10 Bottom Z bar**

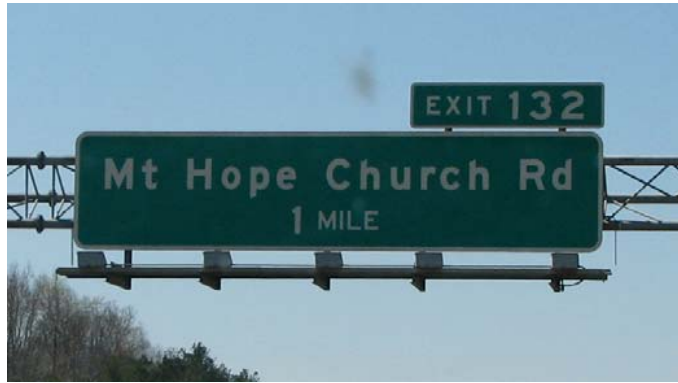
**Figure 24 - Sign Structure 400650**

County	Guilford
Division	7
Route	I-40 / I-85
Structure Type	Span
AADT	40500
# 400650	Sign 11
Size	29'x6'
Z-bars	2
Total Studs	356
Missing Studs	23
% Missing	6.5
Thru-bolts	Yes
Fab/Erect Date	1992

This structure (Figure 24) is missing 6.5% of its visible studs, but the top Z-bar was blocked from view by the structure itself. It is possible that the sign exceeds the 10% failure rate, but it is unlikely. The bottom Z-bar was missing eight studs. If the top mirrors the bottom, the sign would only approach 9% failure. Since the majority of the failures occurred in the splice plate, it would be unlikely for the top bar to have suffered heavier failures. The bottom bar failures were localized though, and this could result in the sign peeling from the failure area (See Figure 25).

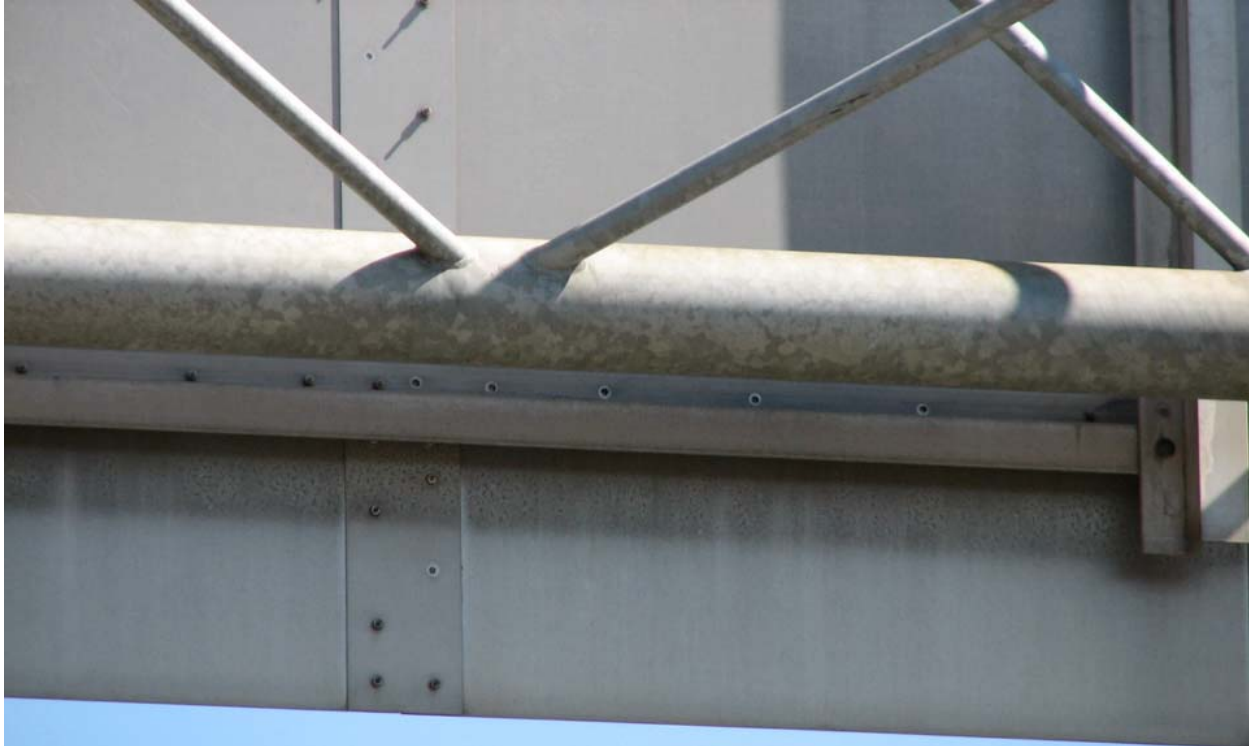
**Figure 25 – Sign 11 Bottom Z bar**

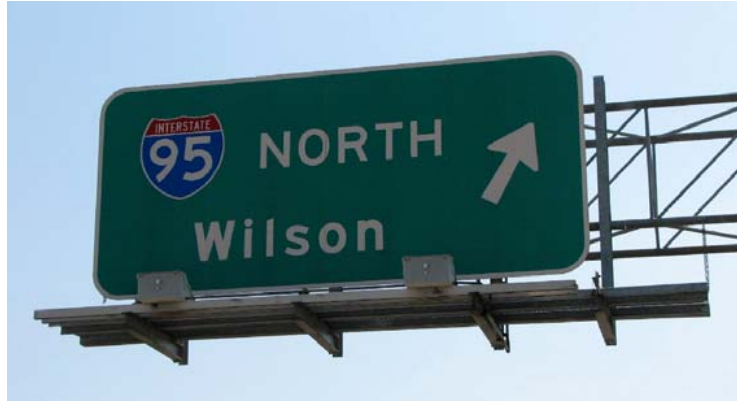
**Figure 26 - Sign Structure 500570**

County	Johnston
Division	4
Route	US-70 EBL
Structure Type	Cantilever
AADT	48,500
# <b>500570</b>	Sign 12
Size	20.5'x12'
Z-bars	3
Total Studs	254
Missing Studs	20
% Missing	7.9
Thru-bolts	No
Fab/Erect Date	None

This structure (Figure 26) had 17 of 20 failures in the splice plates. The Z-bar studs were generally intact. The sign does not have thru-bolts, indicating a pre-1992 erection. Figure 27 shows three of the splice plate failures. Notice the failure underneath the Z-bar. The failures were not localized, as this picture indicates the tightest grouping of failures found on the sign.

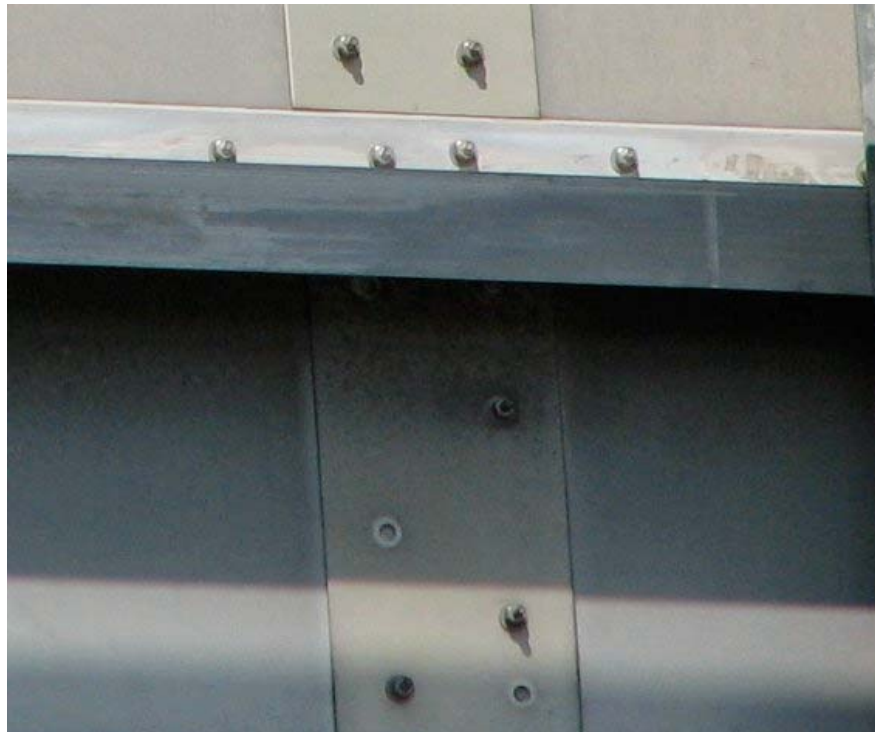
**Figure 27 – Sign 12 Splice Plate**

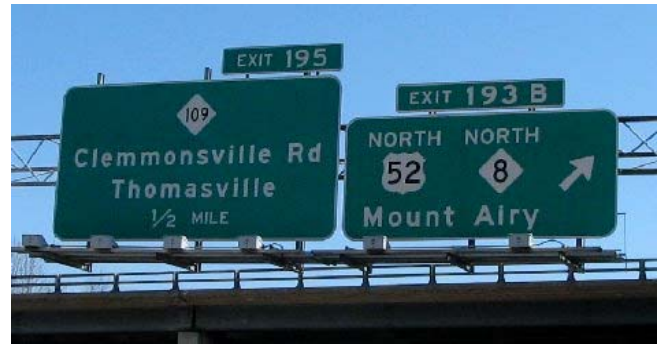
**Figure 28 - Sign Structure 330328**

County	Forsyth	
Division	9	
Route	I-40	
Structure Type	Span	
AADT	48,500	
# 330328	Sign 13	Sign 14
Size	21'x12'	18'x9'
Z-bars	3	3
Total Studs	298	250
Missing Studs	1	16
% Missing	0.3	6.0
Thru-bolts	Yes	No
Fab/Erect Date	2000	1990

This structure is located in Forsyth County (Figure 28). Sign 14 was fabricated in 1990, so it does not have through bolts. The stud failures occur in the top and bottom Z-bar and in the splice plates. The failures are generally spread out and are not localized into one region. Figures 29 and 30 are the stud failures with the tightest grouping. Sign 13 was replaced in the year 2000.

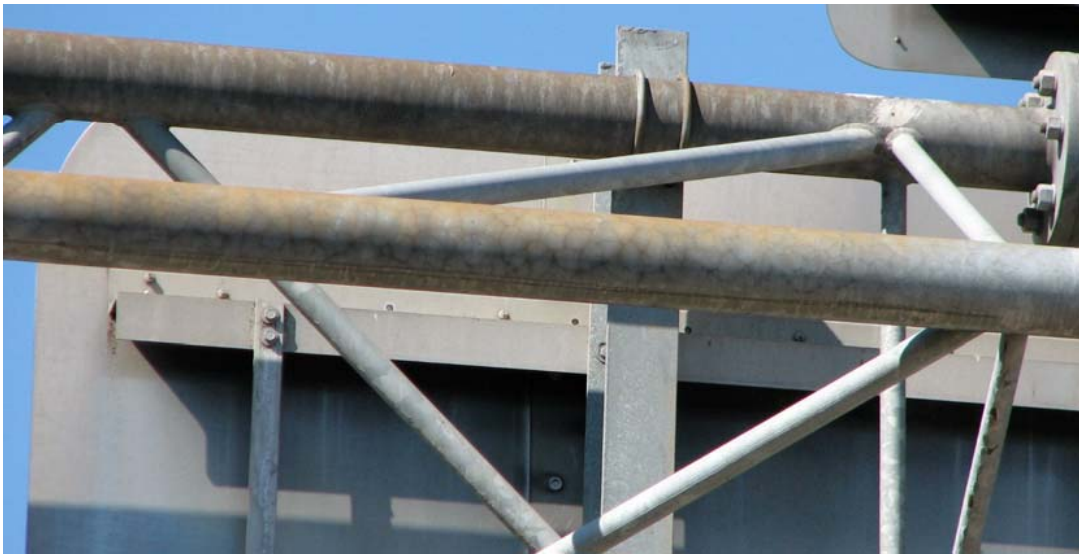
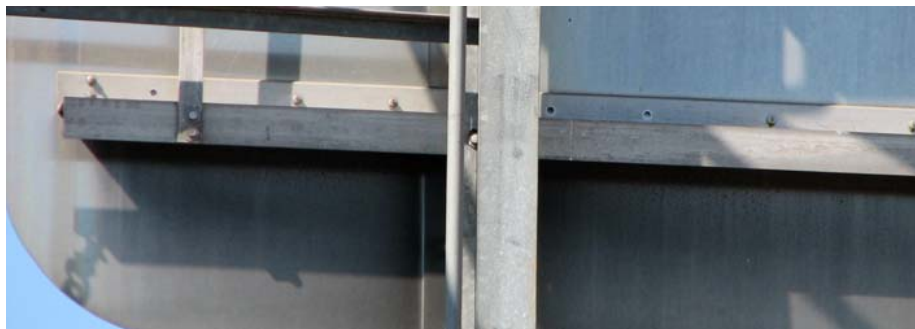
**Figure 29 – Sign 14 Top Z bar**

**Figure 30 – Sign 14 Bottom Z bar**

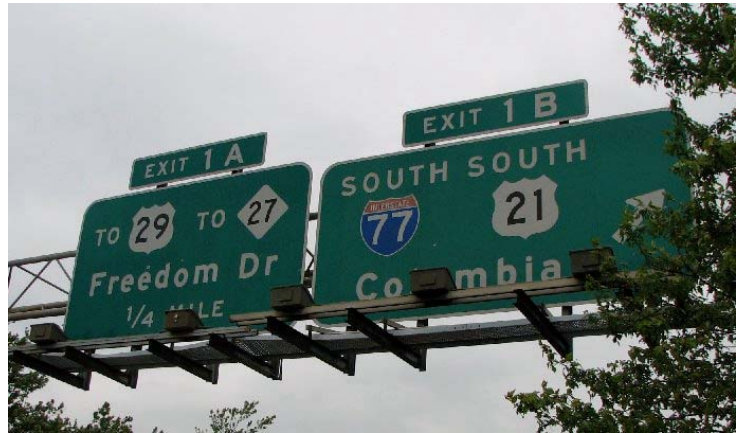
**Figure 31 – Sign Structure 590490**

County	Mecklenburg	
Division	10	
Route	I-277	
Structure Type	Span	
AADT	41,000	
# 590490	Sign 15	Sign 16
Size	15'x10.5'	17.5'x10'
Z-bars	3	3
Total Studs	225	269
Missing Studs	12	16
% Missing	5.3	5.9
Thru-bolts	No	No
Fab/Erect Date	None	None

These signs are not thru-bolted and do not have dates (Figure 31). The absence of thru-bolts indicates that the latest possible fabrication year would be 1992. The failures are primarily in the Z-bars, but they are not localized. Figures 32-35 display the stud failure groupings from the two signs.

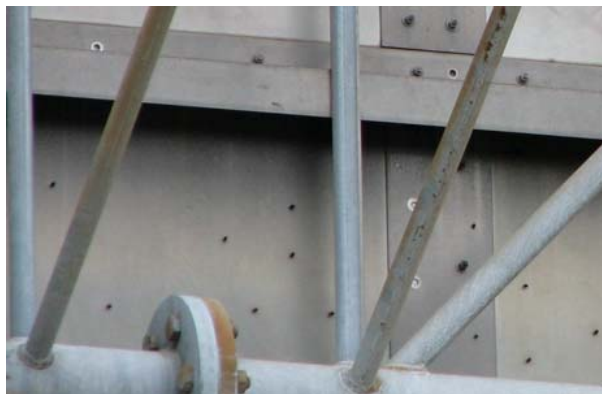
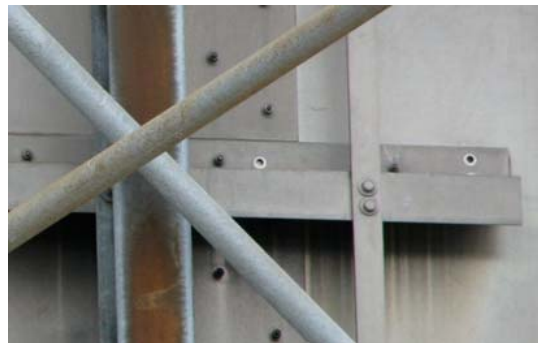
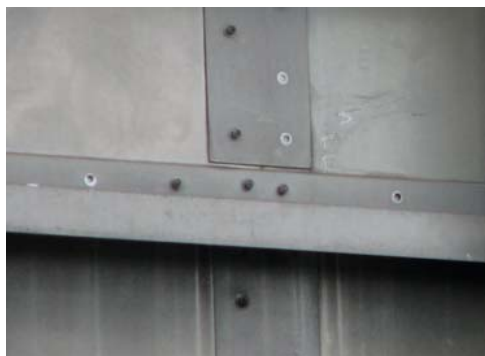
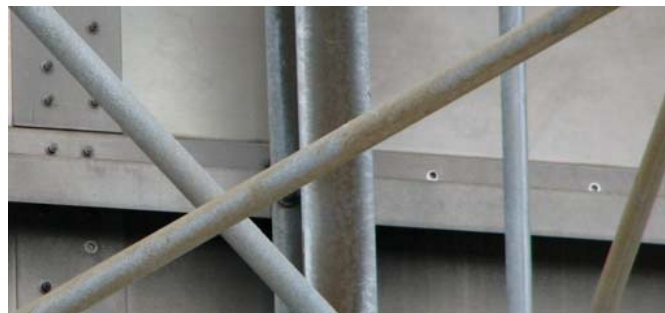
**Figure 32 – Sign 15 Middle Z bar**

**Figure 33 – Sign 16 Middle Z bar**

**Figure 30 – Sign 14 Bottom Z bar**

**Figure 35 – Sign 15 Middle Z bar**

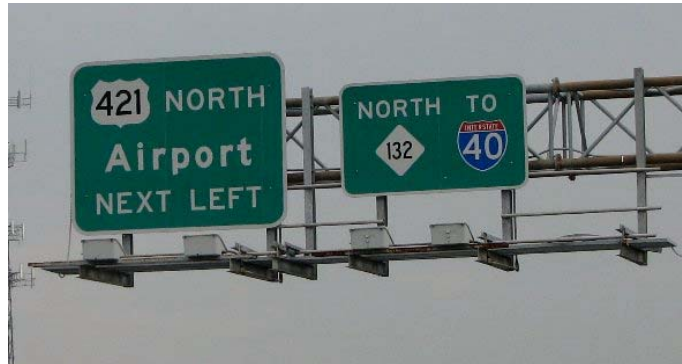
**Figure 36 – Sign Structure 640077**

County	New Hanover	
Division	3	
Route	US 421	
Structure Type	Cantilever	
AADT	11,500	
# 640077	Sign 17	Sign 18
Size	9'x7'	7'x4'
Z-bars	2	2
Total Studs	105	55
Missing Studs	0	3
% Missing	0.0	5.5
Thru-bolts	Yes	Yes
Fab/Erect Date	1992	1992

This structure is located in New Hanover County (Figure 36), where there are stronger winds. The stud failures are small in number. However, in this case it is likely that the missing studs are more of an anomaly than a potential problem. Also, the failures are in the splice plate, and are not providing structural support to the sign.
